EXTERIOR TRIM

OPTION CLASSIFICATION CASE STUDY

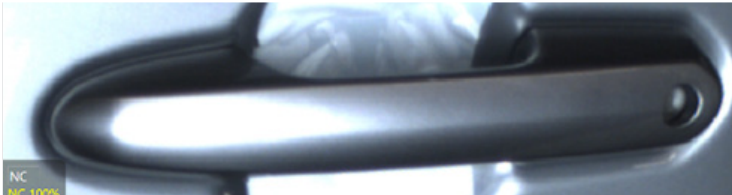
Door Handle	Vehicle Colour	BOS I-DV Result	
Painted	Silver

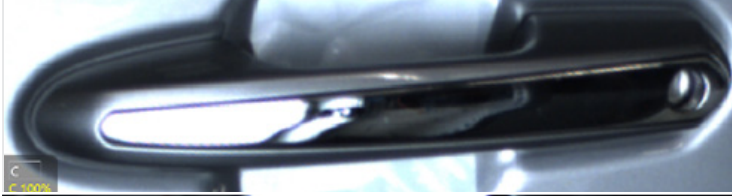
✓
Chrome	Silver

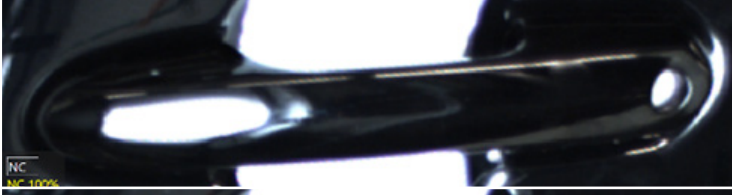
✓
Painted	Black

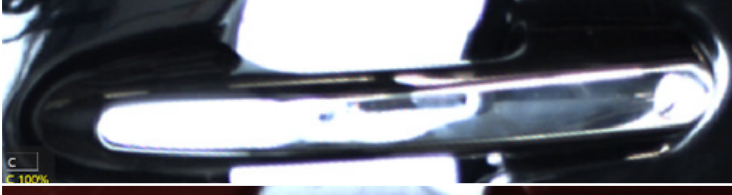
✓
Chrome	Black

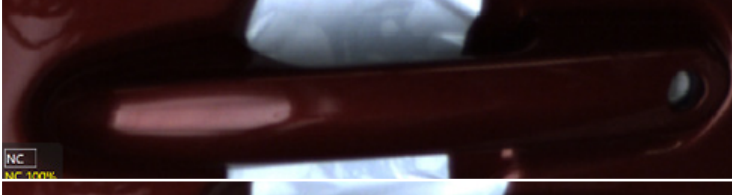
✓
Painted	Red
