# SEAT WRINKLE

## DEFECT DETECTION CASE STUDY

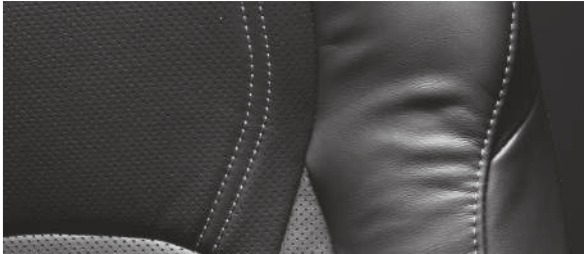
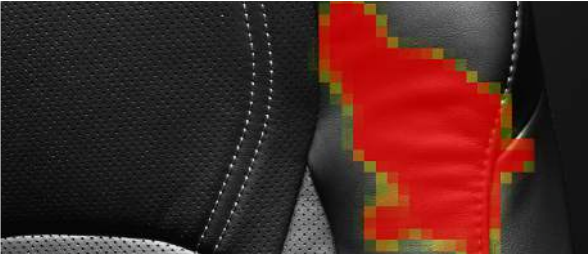
Before Image	BOS I-DV Result
Defective

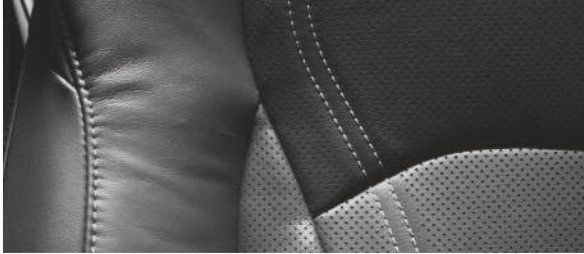
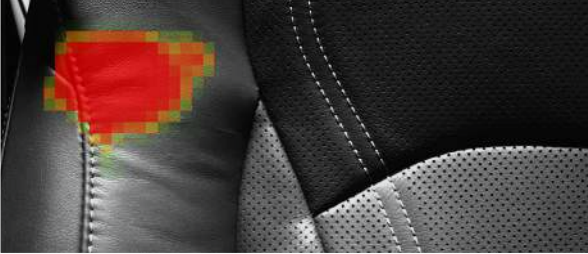
Defective

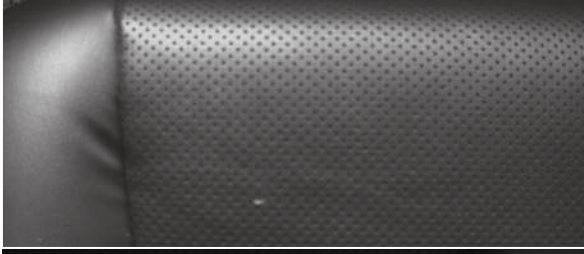
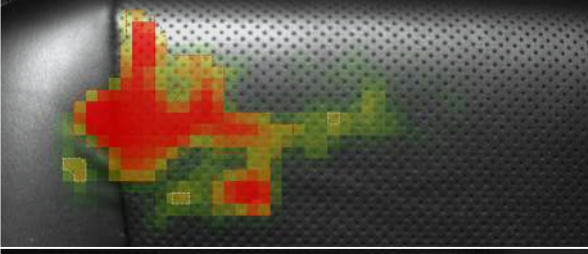
Defective

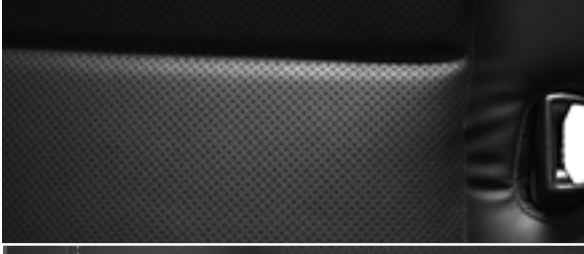
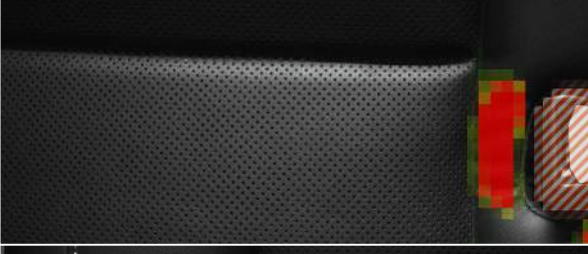
Defective
